LIFT STATION REPAIRS

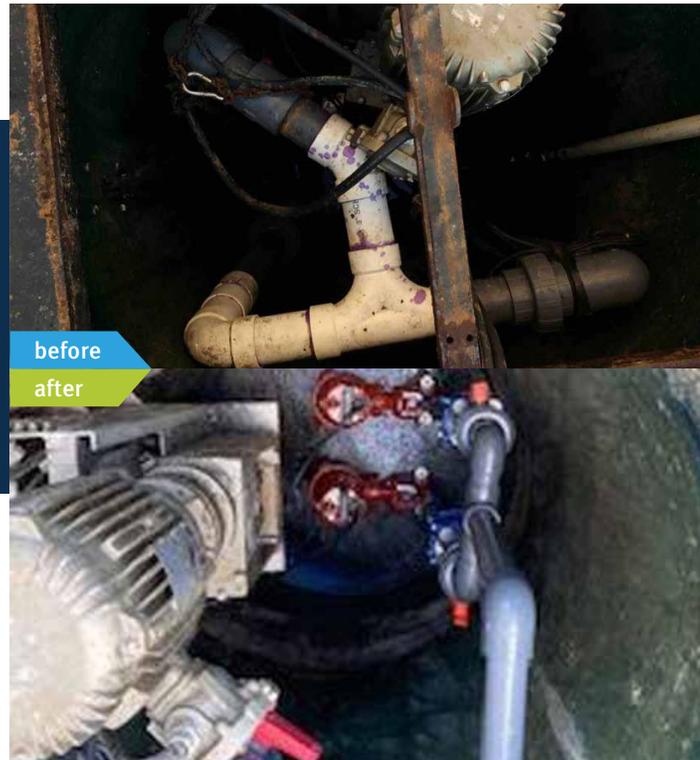
When AQUALIS was first brought onsite, the system had been through so many contractors, attempted repairs, and makeshift adjustments that AQUALIS' Lift Station Senior Director could only refer to what he saw as "Frankenstein pipes." The station was poorly configured and poorly maintained.

AQUALIS specialists got to work by inspecting the entire system, rather than just assessing the pipes where clogging had occurred. Through this in-depth system analysis, the team was able to identify the current location and placement, as well as the lack of maintenance of the grinder to be one of the root causes of continued clogging. Due to its placement, it was not able to properly shred any foreign materials that may make their way into the system and therefore allowed large clumps of toilet paper, flushable wipes, and other debris to accumulate within the pipes. The hard piping that was used throughout the discharge system was another key problem that prevented the system from being adequately maintained. Due to the numerous repairs done by previous contractors, the piping was no longer a straight line and instead bent in all directions and switched between a variety of materials. This allowed materials to collect within the unnecessary turns and less than ideal connections between sections of pipe.

To prevent future reoccurrence, AQUALIS removed the grinder, as well as all the pumps and discharge piping. A full and deep [jetting](#) cleaned the station of any remaining accumulation and sedimentation. New pumps and level controls were implemented. To straighten the flow pattern and minimize areas where materials can catch, all new and consistent piping was installed. The grinder was rebuilt due to components that had not been maintained and were well past their lifespan. Since the completion of this project, the site has received routine maintenance with no failures.
