## SINKHOLE RESTORATION

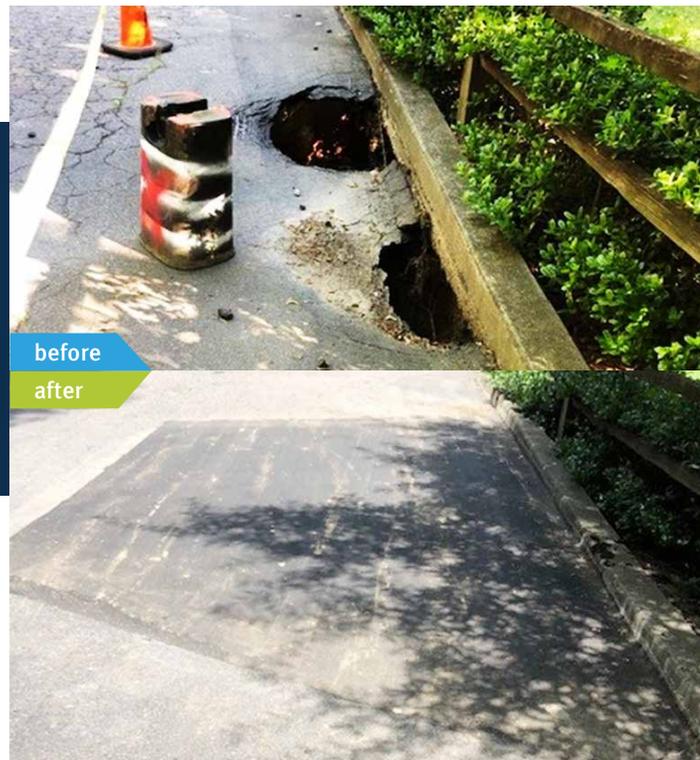
Two sinkholes had formed in a drive lane above large diameter conduits. These pipes are designed to guide stormwater runoff and have faced years of wear and showed signs of extreme corrosion that inevitably lead to a displaced retaining wall. No longer adequately set, stormwater was misguided around the outside of the conduits rather than through them. These compromised pipes led to the destabilization of the surrounding surfaces and stormwater erosion created pockets of subsurface caverns. Eventually, the road above these hollows became so weakened they imploded, revealing the sinkholes.

AQUALIS engineers performed a centrifugally cast concrete pipe lining repair on the pipes as the pipes were still in a healthy condition. Using this technique, AQUALIS professionals created a 1.5" concrete pipe within the existing conduits. This process seals the pipe from further damage and increases the stability of the conduits to prevent additional stormwater from being diverted around the pipes.

Once the conduits were stabilized, grout was injected around the pipe headwalls and within the sinkhole to fill the voids and compact the soil, securing the pipe repair. Once the sinkhole was filled, damaged asphalt was replaced, and the entire drive lane was safe to travel on once again.
