HALLANDALE BEACH, FL
COMMERCIAL
LIFT STATION REPAIRS

LIFT STATION REPAIRS

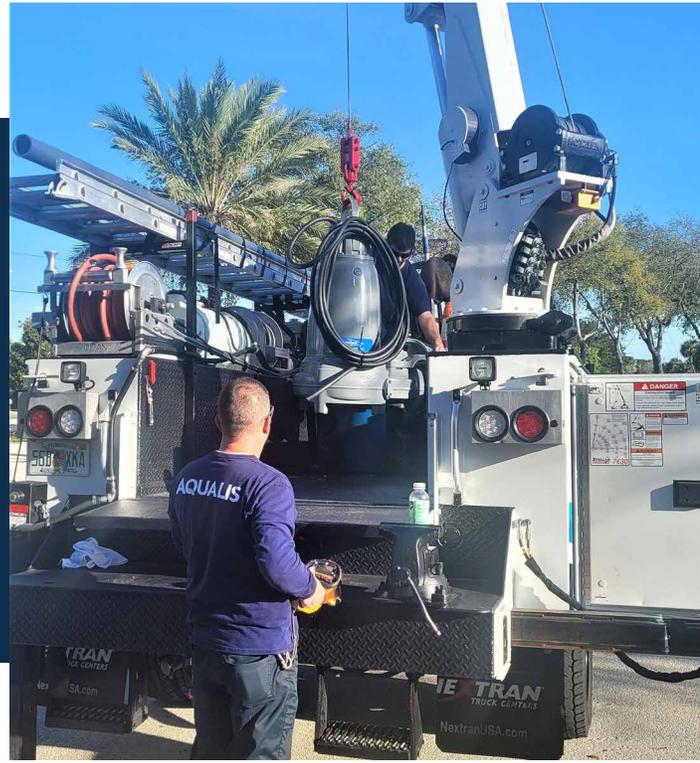
Preventative maintenance on site of a horse complex led to required replacement of lift station pumps. AQUALIS identified the issue and installed new, functioning pumps before system failure.

During a routine, monthly preventative maintenance visit, AQUALIS determined the existing lift station pumps were showing signs of failure and were in need of replacement. Signs of lift station failure include pumps pulling high amp measurements indicative of system strain. When pumps are clogged or beginning to fail, the system is put under immense stress which and requires more energy to do a less efficient job. During routine maintenance, all elements of functionality is checked including amp draw, float activation functionality, visual inspection of all components, and the level of debris accumulation in the wet well. Other lift station failure red flags include staining on the walls of the wet well that show the levels were high after last maintenance check, alarms not activating in high level alarm, and large amounts of floatable debris or grease accumulation.

The lift station professionals at AQUALIS were able to order new pumps in a timely manner and install three replacement pumps before system failure. Without preventative maintenance, these pumps would have failed, and the site would require full remediation. The remediation process timeline ranges from a few days to multiple months depending on available parts and debris in the waste stream. AQUALIS was able to avoid supply chain delays by noticing signs of failure early and acting quickly.

With replacement of three lift station pumps, professionals at AQUALIS positioned the property owners up for success. A routine maintenance plan is essential for successful lift station management and avoiding costly repairs.
